**The Woods at Little River**  
*Little River, CA*

Report #: 51033-0

**RESERVE STUDY**  
"Full"

November 8, 2024

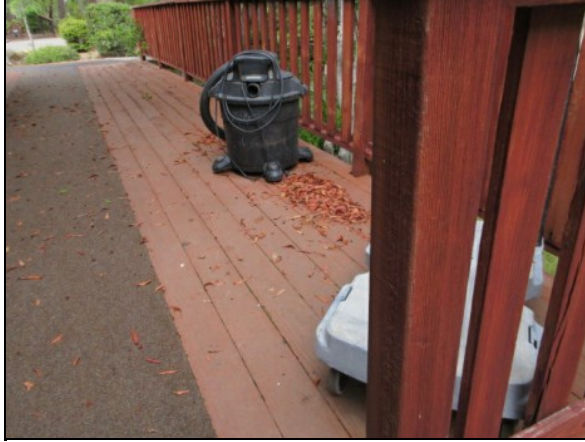
Comments: It is our understanding that the client is planning to replace this deck in the upcoming fiscal year.

Useful Life:  
30 yearsRemaining Life:  
0 years

Best Case: \$ 16,000

Worst Case: \$ 20,000

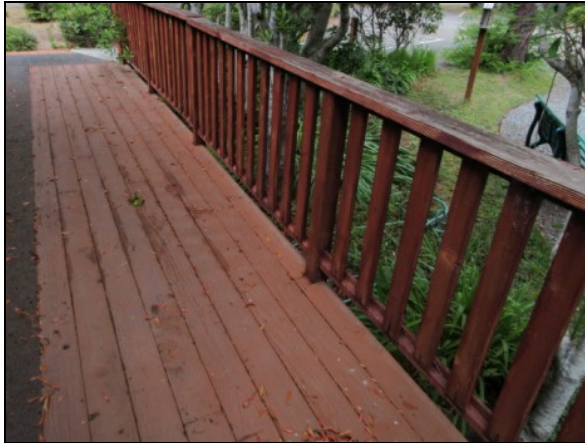
Comments: We recommend resealing wood surfaces every 4-5 years to protect deck surfaces and to prolong costly repairs and replacements. This component will start cycling after the deck is replaced.

Useful Life:  
5 yearsRemaining Life:  
5 years

Best Case: \$ 2,100

Worst Case: \$ 2,940

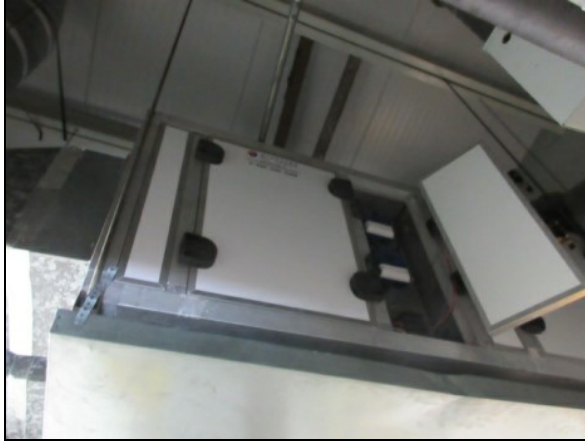
Comments: No reported problems at this time. We recommend periodic inspections by a licensed professional to ensure the unit is fully functional and aging correctly.

Useful Life:  
20 yearsRemaining Life:  
12 years

Best Case: \$ 35,000

Worst Case: \$ 45,000

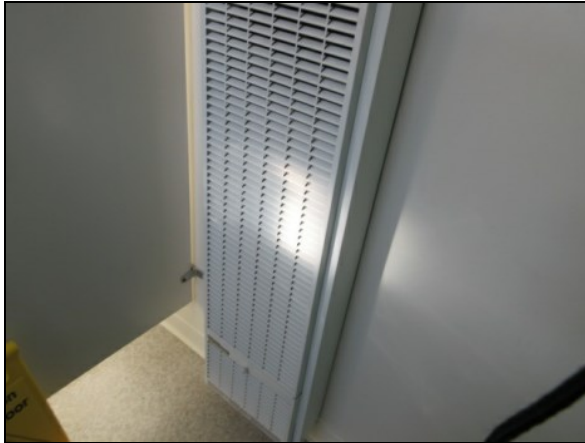
Comments: No reported problems at this time. The wall heater should be inspected and serviced regularly throughout its life cycle to ensure optimal performance and a full useful life. As the remaining useful life approaches zero, consult with licensed vendors to determine replacement options.

Useful Life:  
25 yearsRemaining Life:  
17 years

Best Case: \$ 9,000

Worst Case: \$ 12,000
