**The Woods at Little River**  
*Little River, CA*

Report #: 51033-0

**RESERVE STUDY**  
"Full"

November 8, 2024

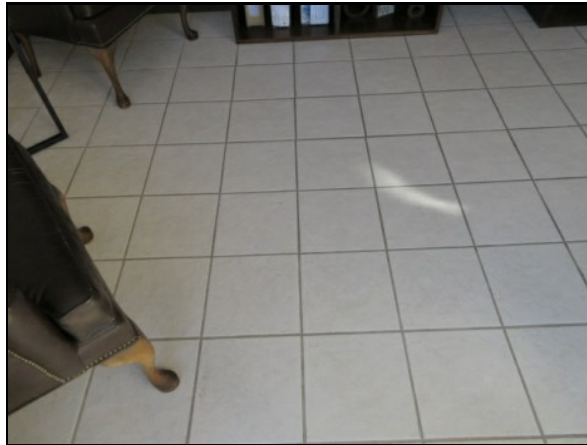
**Comp #: 603 Tile Floor - Replace**

Comments: No major cracking or areas of detachment. As part of the ongoing maintenance program, inspect regularly, repairing or replacing damaged sections as needed. With ordinary care and maintenance, tile in interior locations can last for an extended period. Still, replacement is often warranted to enhance and restore aesthetic appeal in common areas. Replacement costs can vary greatly depending on the size and type of tiles selected.

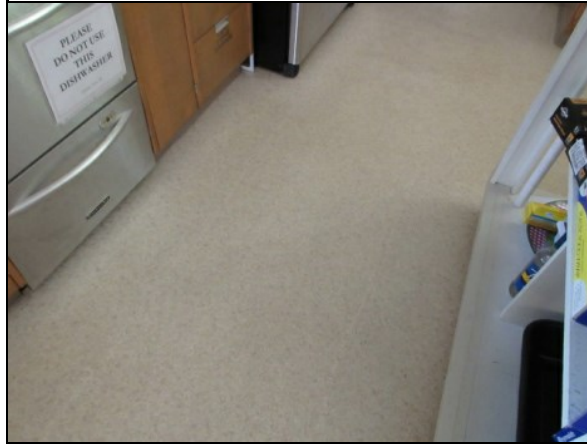
**Comp #: 607 Vinyl Floor - Replace**

Comments: The floor has a dated appearance and displays general surface wear. We have cycled replacement with other interior projects for cost-effectiveness.

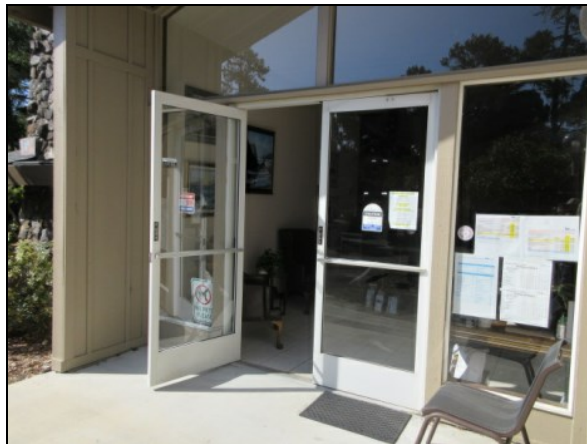
**Comp #: 703 Exterior Doors - Replace**

Comments: The doors are intact and functional. They have a satisfactory seal and appear to be aging correctly. We recommend setting aside funding for replacement in the interval outlined below.

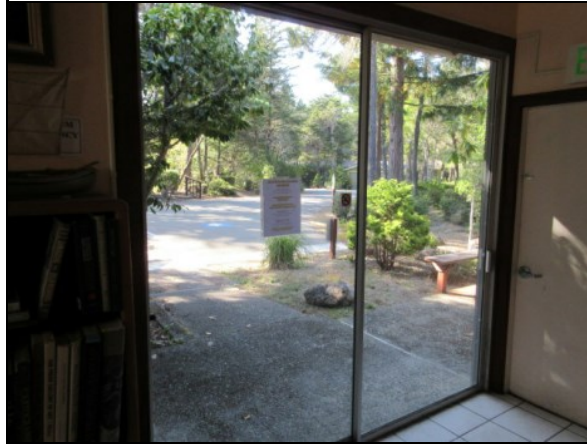
**Comp #: 712 Sliding Glass Doors - Replace**

Comments: Even with ongoing maintenance, plan for replacement at the indicated below. The sliding glass doors are older, and we assume replacement is not a top priority. Adjust funding as needed in future years.

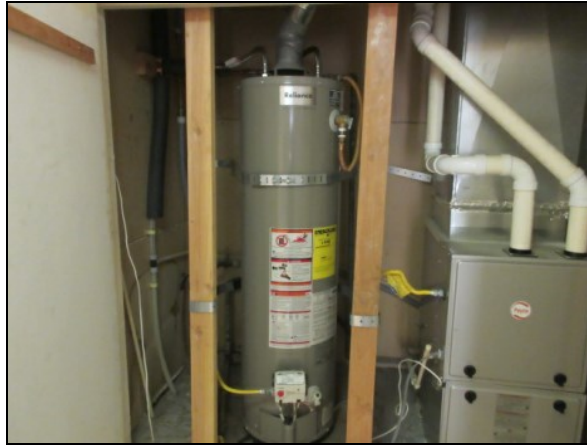
**Comp #: 803 Water Heater - Replace**

Comments: (1) Reliance 30-gallon heater, model 630LORT301, 32k BTU. It is best to plan for replacement within the typical life expectancy of ten to fifteen years. Regular inspections and maintenance are recommended. Flush the tank and inspect the pressure relief valve each year.

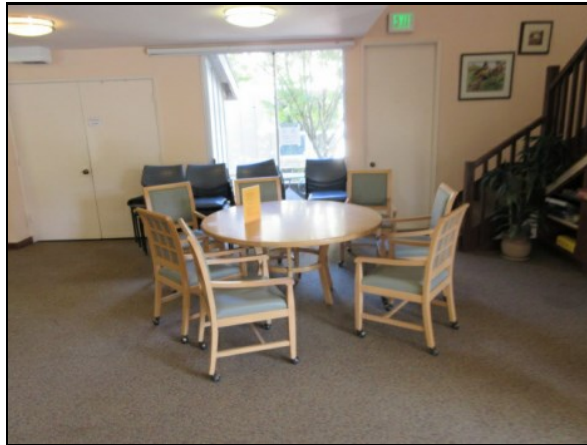
**Comp #: 901 Furniture/Furnishings - Replace**

Comments: This component recommends funding for periodic replacement/refurbishment of interior furnishings and decor, such as furniture, artwork, window treatments, misc. decorative items, etc., to maintain a desirable aesthetic in the common areas. Cost estimates can vary greatly depending on the number of items to be replaced at each project and the style and quality of replacement options.

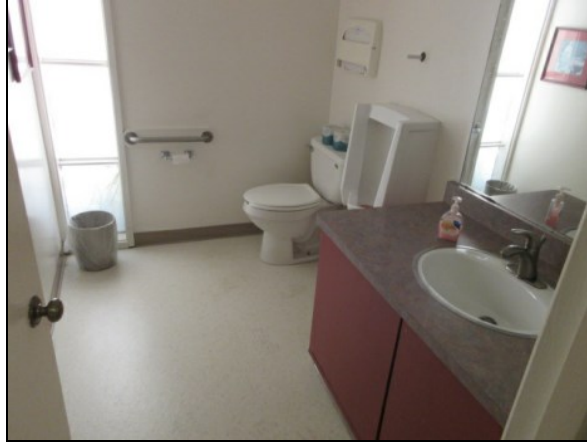
Comments: As routine maintenance, inspect regularly and perform any needed repairs promptly utilizing general Operating funds. A typical remodeling project can include some or all of the following: replacement of plumbing fixtures, partitions, countertops, lighting, flooring, ventilation fans, accessories, décor, etc. The timing for refurbishment of the bathrooms is highly dependent on the level of aesthetics desired by the client. This component provides an allowance for general refurbishment at the interval indicated below.

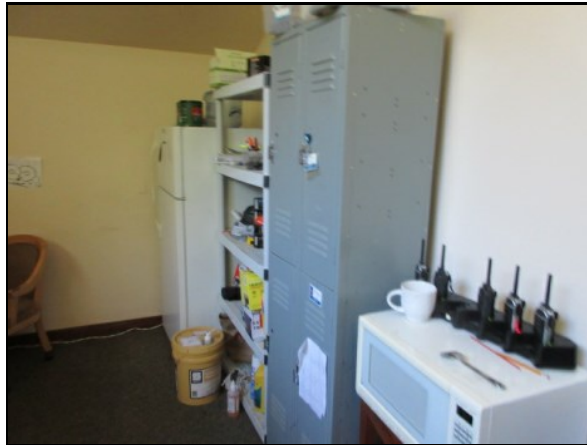
**Comp #: 911 Break Room Appliances - Replace**

Comments: No reported problems at this time. This component provides funding to replace the appliances in the interval outlined below.

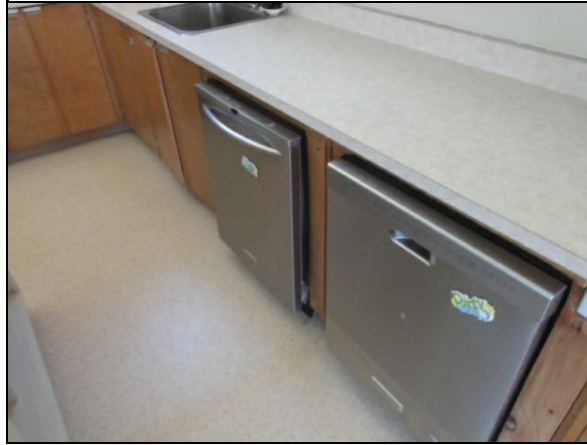
**Comp #: 911 Kitchen Appliances - Replace**

Comments: No reported problems at this time. This component provides funding to replace the appliances in the interval outlined below.

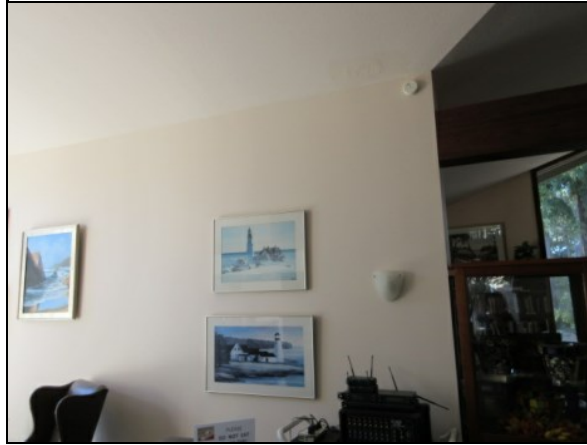
Comments: Regular repainting cycles are recommended to maintain appearance. If possible, coordinate with flooring replacement. Keep touch-up paint on site for projects in between cycles.

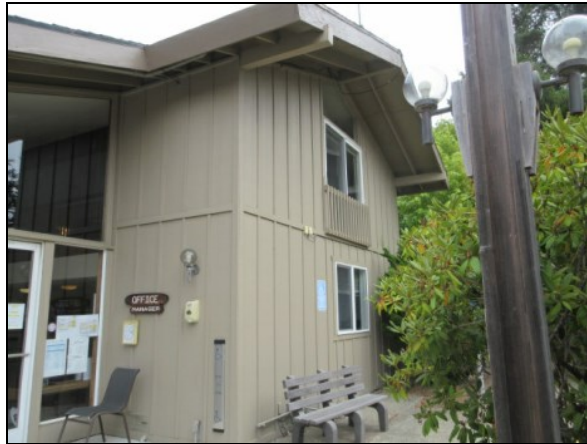
Comments: The paint is new and in fair condition. No peeling or other indications of premature deterioration noted. Painting is recommended every 10 years to preserve the exterior building surfaces and maintain appearance.

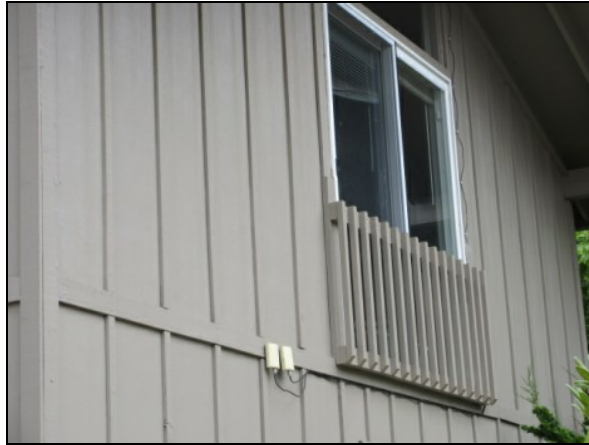
**Comp #: 1117 Building Exterior - Repair**

Comments: Funding is recommended for partial wood replacement due to the potential for termite damage, wood rot, and natural deterioration. Coordinate with painting for cost-efficiency purposes. We recommend an inspection by a licensed professional before painting to determine the scope of needed repairs. Adjust funding as future conditions dictate.

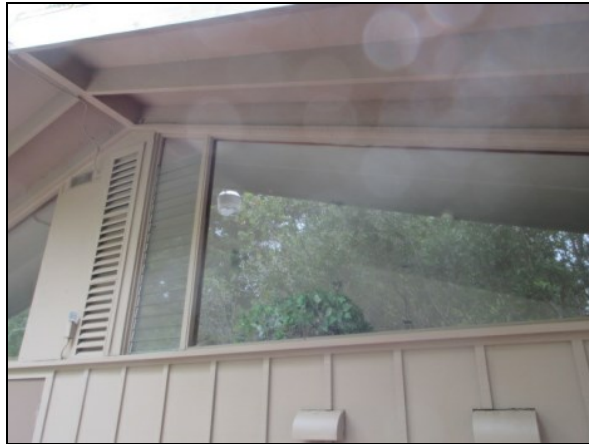
**Comp #: 1137 Windows - Replace**

Comments: We assume replacement is not a top priority. Adjust the timing of replacement as needed.

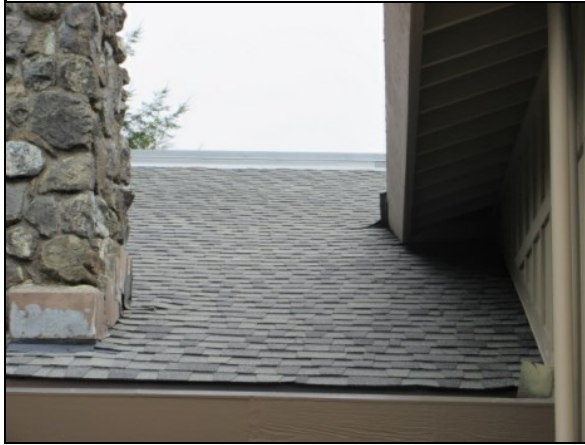
**Comp #: 1303 Comp Shingle Roof - Replace**

Comments: The roof has been repaired over the years. No reported problems at this time. We recommend regular inspections by a licensed professional and setting aside funding for replacement in the interval outlined below.

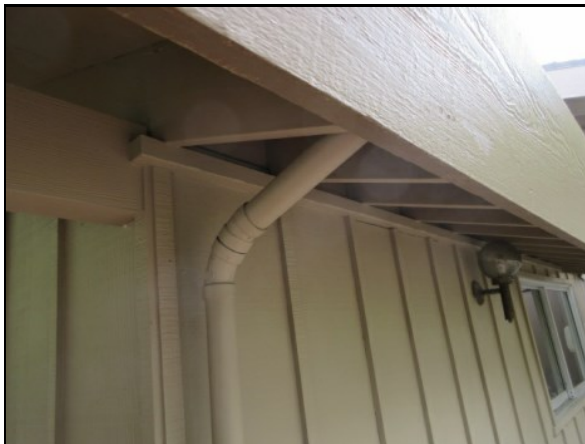
**Comp #: 1312 Gutters/Downspouts - Replace**

Comments: Inspect regularly, keep gutters and downspouts free of debris to ensure water evacuating from rooftops as designed, and repair as needed from general operating funds. Planning for replacement at the same intervals as roof replacement cost efficiency is best.

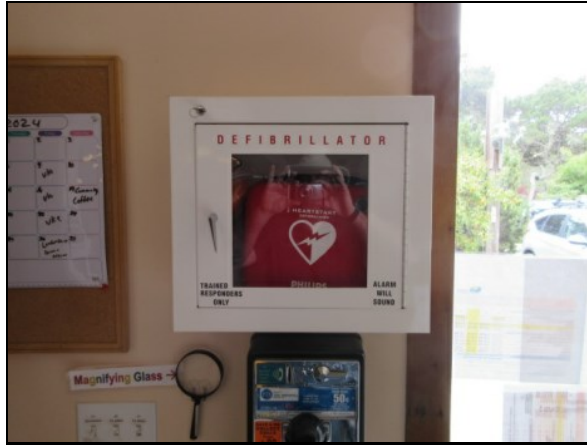
**Comp #: 1825 Defibrillator - Replace**

Comments: We are not licensed to test defibrillators. We recommend replacement in the interval outlined below.

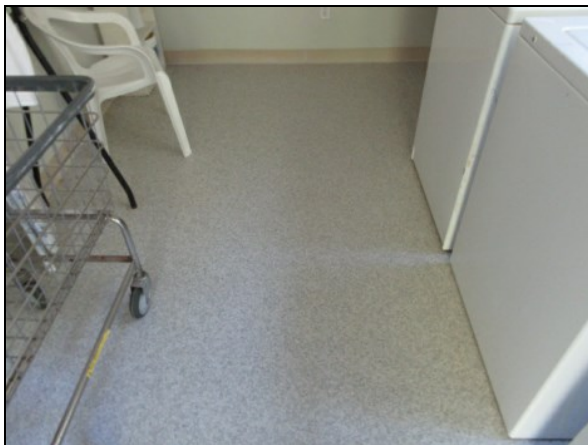
**Comp #: 607 Vinyl Floor - Replace**

Comments: The flooring has a dated appearance. Replacement timing is somewhat dependent on the tastes of the association. Although vinyl flooring is long-lasting and low maintenance, it will eventually need to be replaced. We recommend replacement at roughly the time frame below.

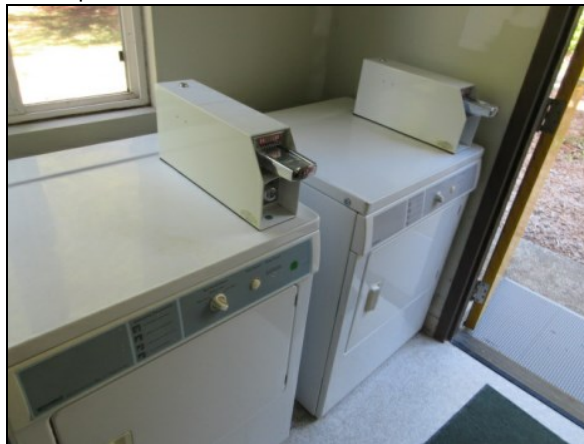
**Comp #: 924 Dryers - Replace**

Comments: (2) Kenmore dryers. No reported problems at this time. We assume the units are nearing the end of their estimated useful life. We anticipate the need for replacement in the interval outlined below.

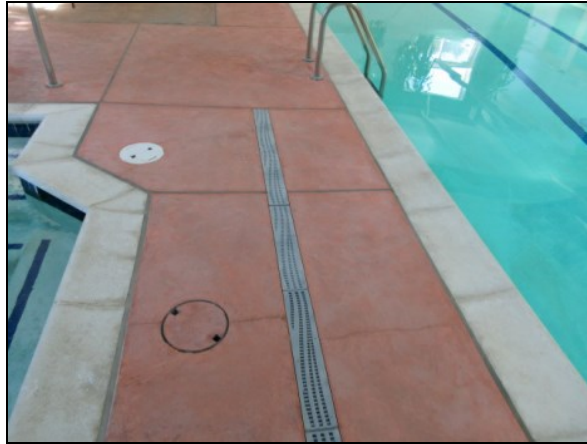
**Comp #: 1201 Pool Deck - Reseal/Repair**

Comments: The pool deck should not need to be completely replaced at any time in the foreseeable future, but occasional repairs may be required. As a routine maintenance expense, inspect the deck closely for trip hazards and other issues. Based on our experience with other properties, an allowance for miscellaneous repairs, replacement, and/or sealing is recommended below. Funding will need to be adjusted in the future should major replacement become necessary.

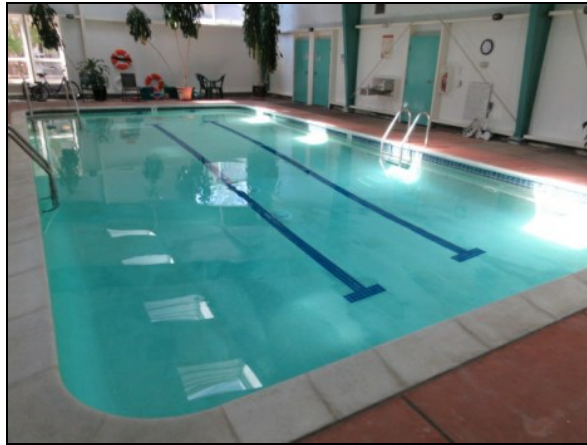
Comments: Plan to reline within the time frame below. We also recommend inspection by a licensed professional to set up an accurate maintenance plan.

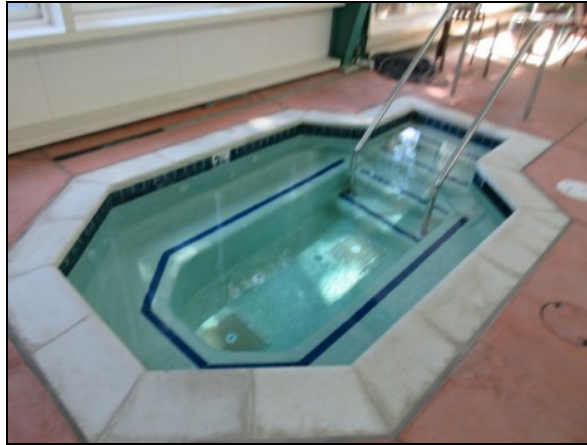
Comments: The spa displays general discoloration consistent with the age of the surface. We recommend proactive cleaning and maintenance and use of cover when possible. We recommend inspection by a licensed professional to set up an accurate maintenance plan.

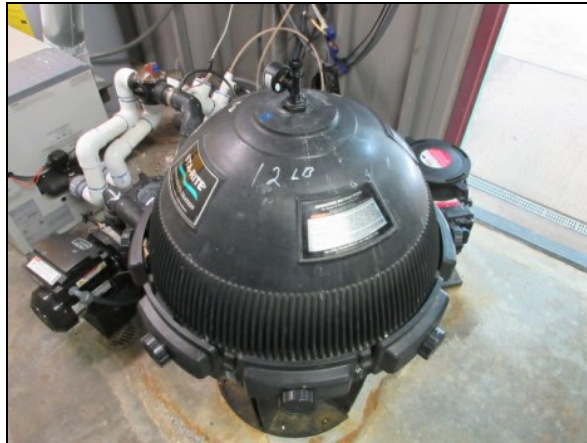
**Comp #: 1206 Pool Filter - Replace**

Comments: (1) Sta-Rite pool filter, model S8M150, serial number 41001531700106. The service vendor should regularly inspect for optimal performance and address necessary repairs or preventive maintenance. We recommend setting aside funding for replacement in the interval outlined below.

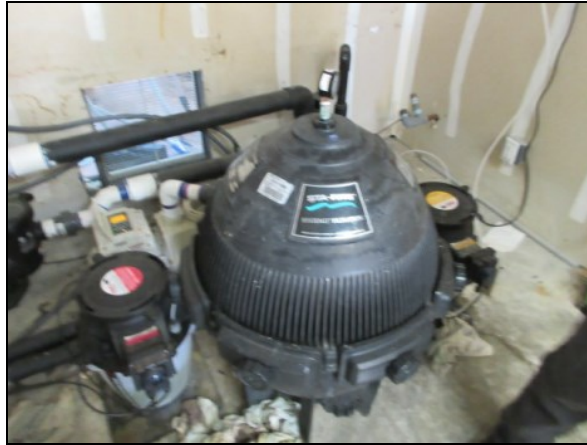
**Comp #: 1207 Spa Filter - Replace**

Comments: (1) Sta-Rite pool filter, model S7M170, serial number 4100167170036P. The service vendor should regularly inspect for optimal performance and address necessary repairs or preventive maintenance. We recommend setting aside funding for replacement in the interval outlined below.

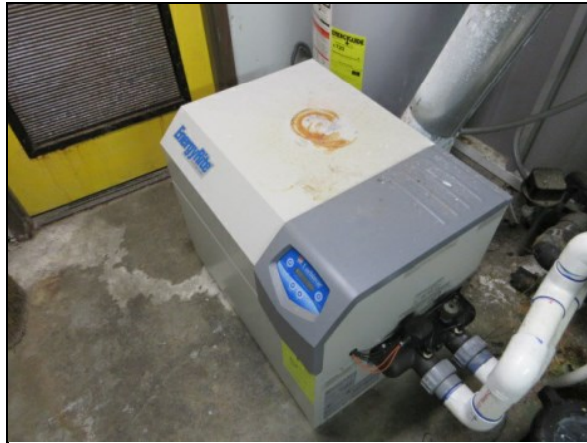
**Comp #: 1208 Pool Heater - Replace**

Comments: (1) Lochinvar EnergyRite heater, model number ERL252, serial number 2205128043082. Plan for regular intervals of replacement at roughly the time frame indicated below. We recommend periodic inspections by a licensed professional to ensure the heater functions correctly.

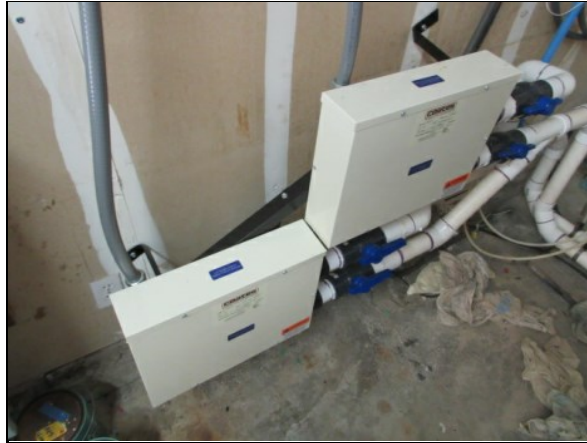
**Comp #: 1209 Spa Heaters - Replace**

Comments: (2) Coates model 12411ST, serial numbers TC24455 and TB24407. Plan for regular intervals of replacement at roughly the time frame indicated below. We recommend periodic inspections by a licensed professional to ensure the heaters function correctly.

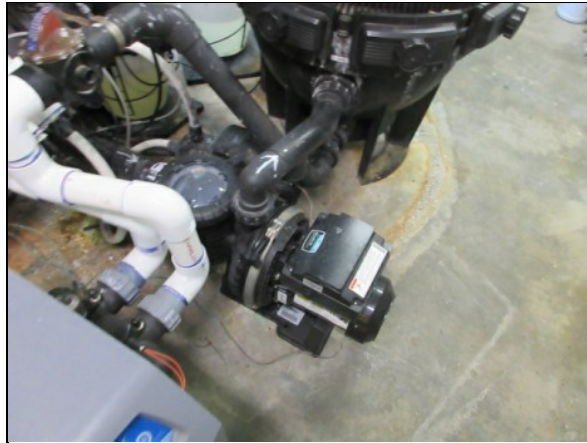
**Comp #: 1210 Pool Pump - Replace**

Comments: (1) Sta-Rite pump, D/N 176L8123, serial 358526D18922SK0145888U. The service vendor should regularly inspect for optimal performance and address necessary repairs or preventive maintenance. We recommend setting aside funding for replacement in the interval outlined below.

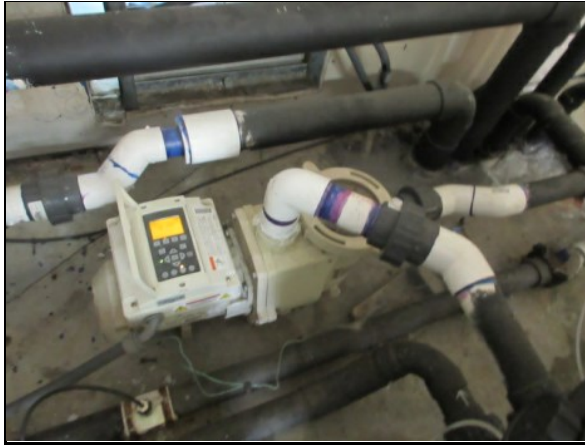
**Comp #: 1211 Spa Pump - Replace (Circ)**

Comments: (1) Sta-Rite pump, D/N 176L8122, serial 357526D20922SK0136170U. The service vendor should regularly inspect for optimal performance and address necessary repairs or preventive maintenance. We recommend setting aside funding for replacement in the interval outlined below.

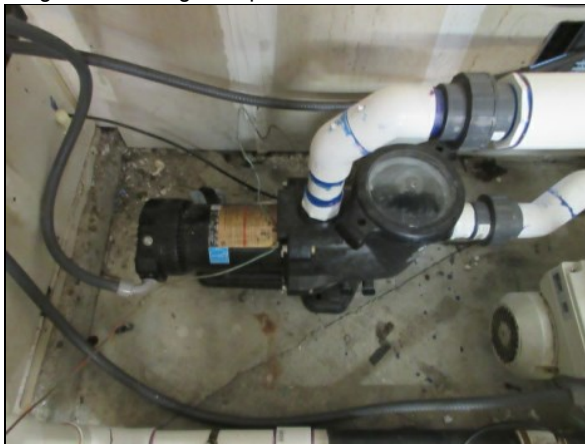
**Comp #: 1211 Spa Pump - Replace (Jet)**

Comments: The service vendor should regularly inspect for optimal performance and address necessary repairs or preventive maintenance. We recommend setting aside funding for replacement in the interval outlined below.

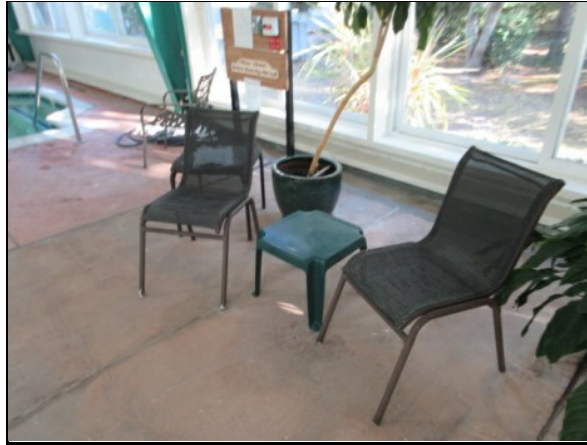
**Comp #: 1219 Furniture/Furnishings - Replace**

Comments: (10) chairs and (14) potted plants. We do not expect the plants will be replaced this funding cycle. The furniture is in moderate condition but nearing the end of its estimated useful life. We recommend setting aside funding for replacement in the interval outlined below.

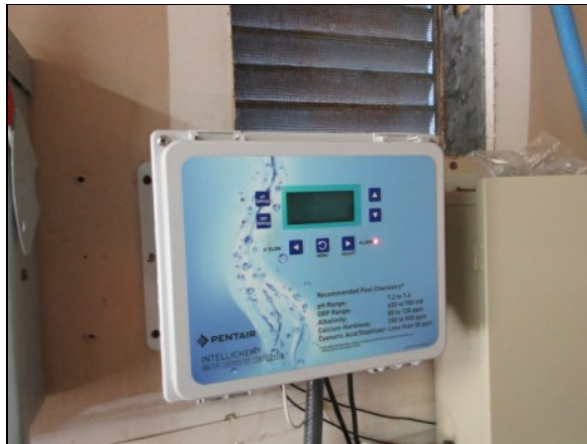
**Comp #: 1227 Chemical Controllers - Replace**

Comments: (2) Pentair chemical controllers. No reported problems at this time. We recommend setting aside funding for replacement in the interval outlined below.

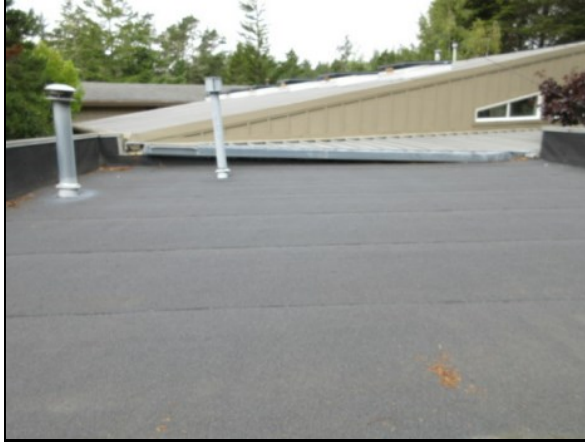
**Comp #: 1308 Flat Roof - Replace**

Comments: The exact age of the roof is unknown. We recommend periodic inspections by a licensed professional to monitor and determine replacement timing. No reported problems at this time. Avoid debris buildup to maximize the useful life of the surface.

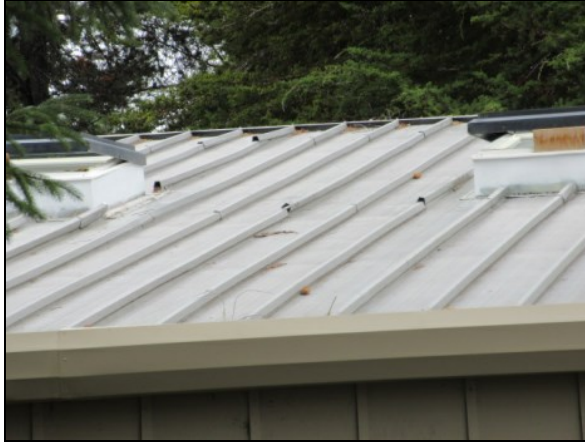
**Comp #: 1309 Metal Roof - Replace**

Comments: The exact age of the roof is unknown. We recommend periodic inspections by a licensed professional to monitor and determine replacement timing. No reported problems at this time. Avoid debris buildup to maximize the useful life of the surface.

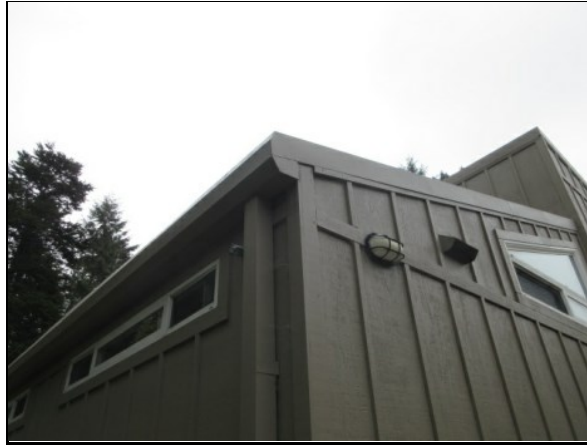
**Comp #: 1312 Gutters/Downspouts - Replace**

Comments: Inspect regularly, keep gutters and downspouts free of debris to ensure water evacuating from rooftops as designed, and repair as needed from general operating funds. It is best to plan for replacement at the same intervals as roof replacement cost efficiency.

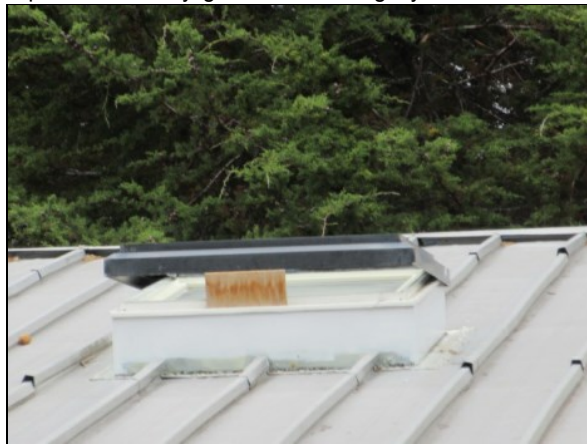
**Comp #: 1314 Skylights - Replace**

Comments: It is best to cycle replacement with roof replacement for cost efficiency. We recommend periodic inspections by a licensed roofing professional to help ensure the skylights are sealed tightly.

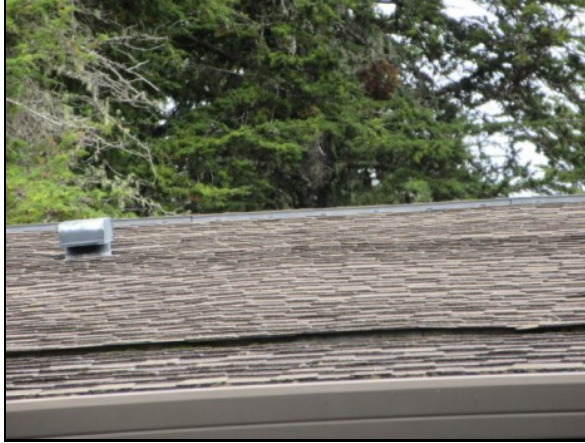
**Comp #: 1303 Comp Shingle Roof - Replace (Lodge)**

History: Replaced in 2010

Comments: We recommend an inspection by a licensed professional to determine the timing of future replacement. We recommend setting aside funding for replacement in the interval outlined below.

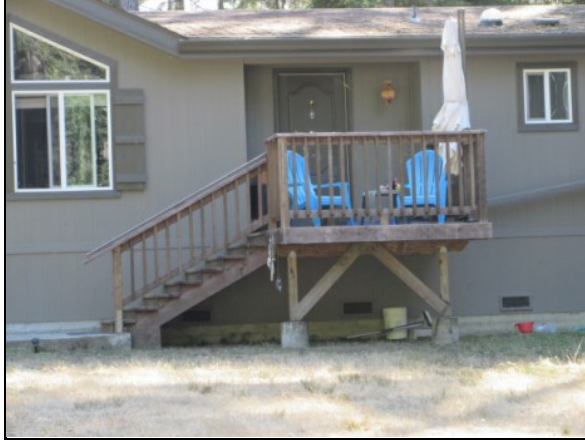
Comments: We were unable to inspect the decks at the time of the site inspection. No problems have been reported. We assume the decks are both intact and aging correctly. We recommend setting aside funding for replacement in the interval outlined below.

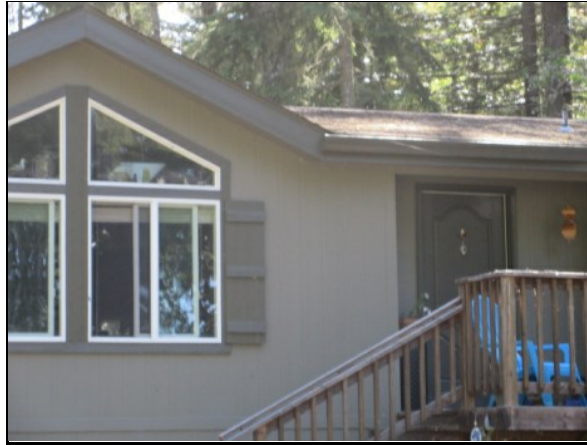
Comments: The paint is intact and appears to be aging correctly. No major peeling or other indications of failure noted. We recommend repainting in the interval outlined below to protect against costly siding repairs and to maintain an attractive appearance.

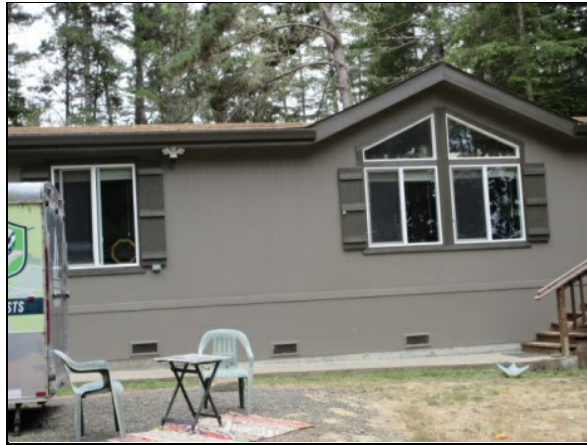
**Comp #: 1117 Building Exterior - Repair**

History: Repaired in 2017

Comments: Funding is recommended for partial siding and trim replacement due to the potential for termite damage, wood rot, and natural deterioration. Coordinate with painting for cost-efficiency purposes. We recommend an inspection by a licensed professional before painting to determine the scope of needed repairs. Adjust funding as future conditions dictate.

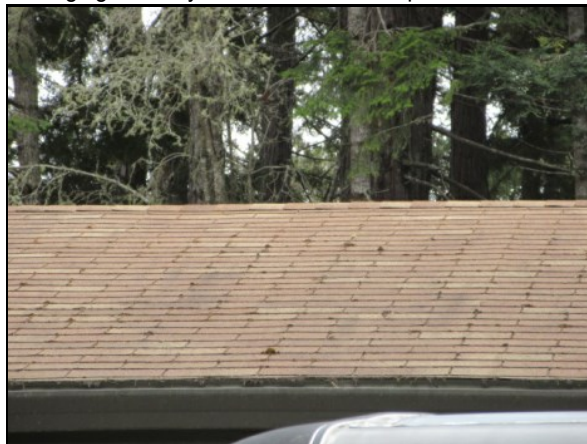
**Comp #: 1303 Comp Shingle Roof - Replace**

Comments: There have been no reported problems at this time. We recommend regular inspections by a licensed professional to ensure the roof is fully functional and aging correctly. Avoid debris build-up to maximize the useful life of the surface.

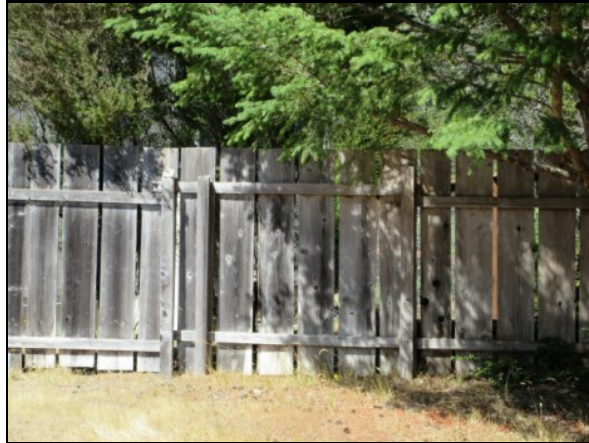
**Comp #: 505 Wood Fence - Partial Replace**

Comments: Conditions vary by age and location. No expectation to replace all areas at one time. This component provides funding for partial replacement in the interval outlined below.

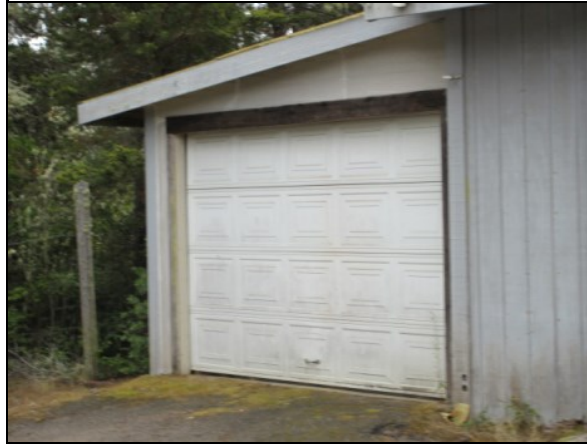
**Comp #: 702 Garage Door - Replace**

Comments: The garage door displays general surface wear and deterioration. We anticipate the need for replacement in the coming years.

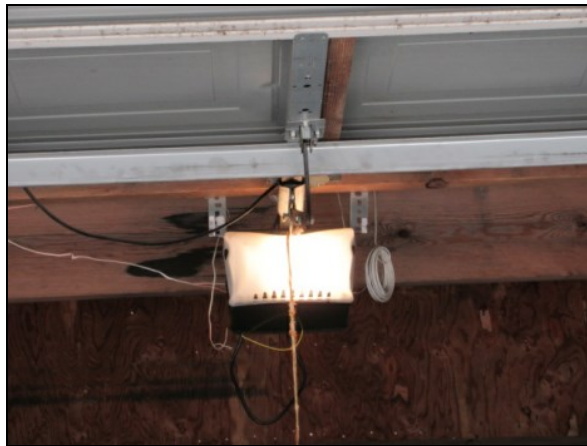
**Comp #: 705 Roll up Door Operator - Replace**

Comments: The operator is functional. No reported problems at this time. We recommend setting aside funding for replacement in the interval outlined below.

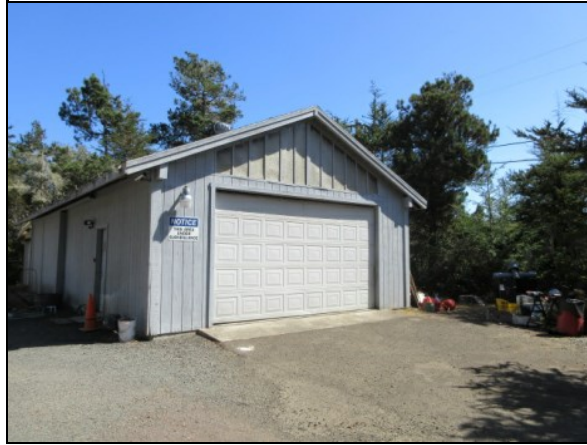
**Comp #: 706 Roll Up Door - Replace**

Comments: The door is functional and has a satisfactory seal. We recommend setting aside funding for replacement in the interval outlined below.

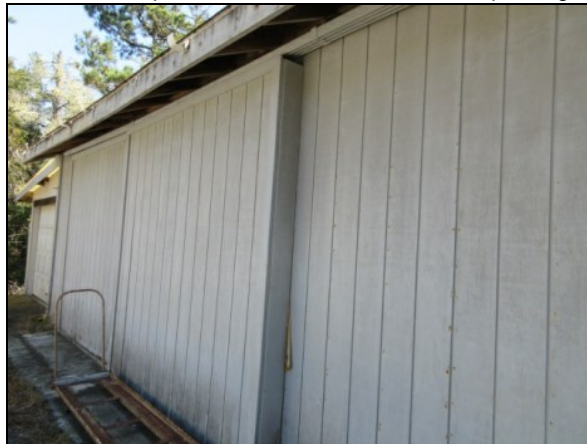
Comments: The paint is worn, dried out, and in poor condition. We recommend repainting at this time.

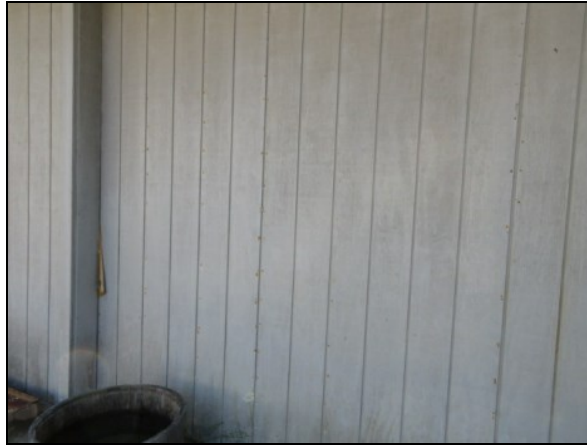
**Comp #: 1117 Building Exterior - Repair**

Comments: Funding is recommended for partial wood replacement due to the potential for termite damage, wood rot, and natural deterioration. Coordinate with painting for cost-efficiency purposes. We recommend an inspection by a licensed professional before painting to determine the scope of needed repairs. Adjust funding as future conditions dictate.

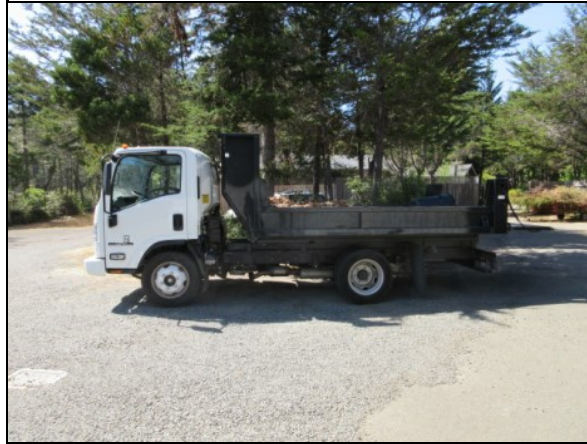
**Comp #: 2633 Dump Truck - Replace**

Comments: (1) Izuzu NPR HD dump truck. The truck is new, and no problems have been reported. With ordinary care and maintenance, plan for replacement at roughly the interval indicated below due to deterioration. To maximize a vehicle's availability, PM services must be performed on a scheduled basis. If preventive maintenance is not performed regularly, the vehicle's life span will be greatly reduced.

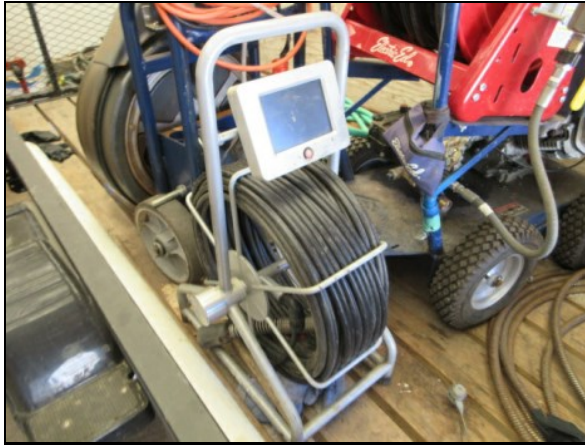
**Comp #: 5202 Backup Sewer Camera - Replace**

Comments: This component provides funding to replace the interval outlined below.

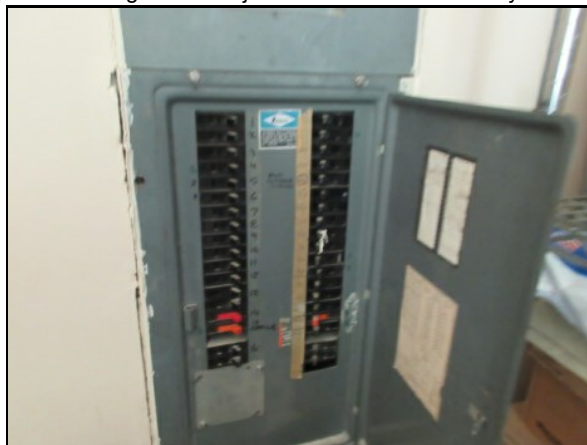
**Comp #: 2638 Electrical System - Repairs**

Comments: This component provides an allowance for general repairs to the electrical system. These repairs include panel replacement and other minor repairs. Funding can be adjusted as needed in future years.

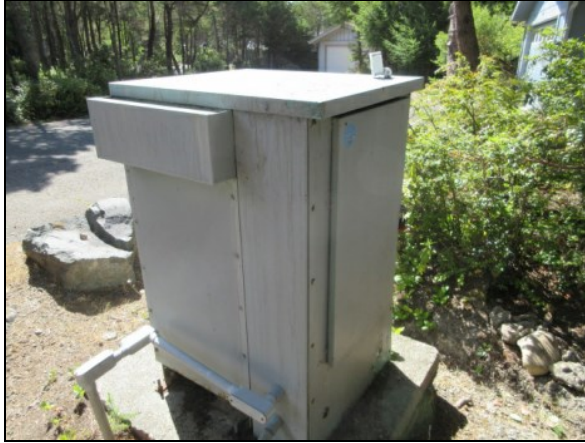
**Comp #: 2640 Transformer/Sub Panels - Repair/Replace**

Comments: Assessing the electrical systems is beyond the scope of our services. We recommend an inspection by a licensed professional to ensure all systems are fully functional and aging correctly.

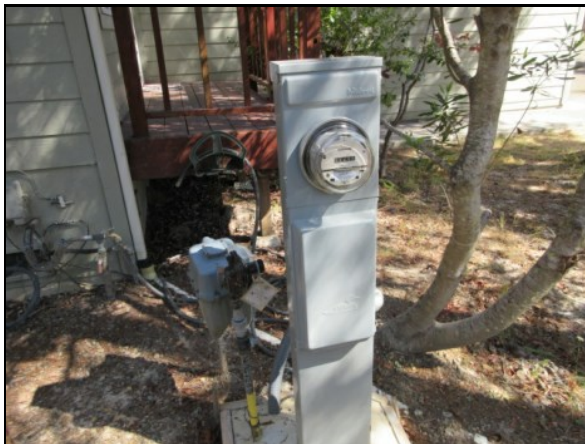
**Comp #: 2641 Electrical Pedestals (2017) - Replace**

Comments: The electric pedestals have been replaced over the past few years. We recommend periodic inspections by a licensed professional to ensure they are fully functional and aging correctly. We also recommend setting aside funding for replacement in the interval outlined below.

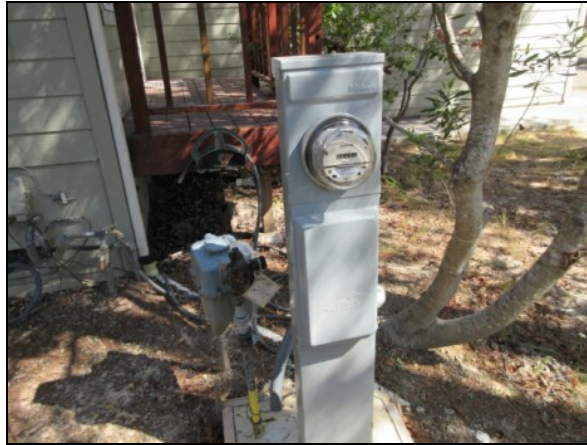
**Comp #: 2641 Electrical Pedestals (2018) - Replace**

Comments: The electric pedestals have been replaced over the past few years. We recommend periodic inspections by a licensed professional to ensure they are fully functional and aging correctly. We also recommend setting aside funding for replacement in the interval outlined below.

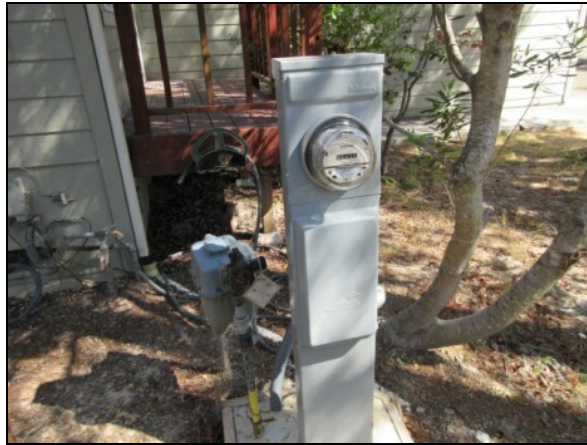
**Comp #: 2641 Electrical Pedestals (2019) - Replace**

Comments: The electric pedestals have been replaced over the past few years. We recommend periodic inspections by a licensed professional to ensure they are fully functional and aging correctly. We also recommend setting aside funding for replacement in the interval outlined below.

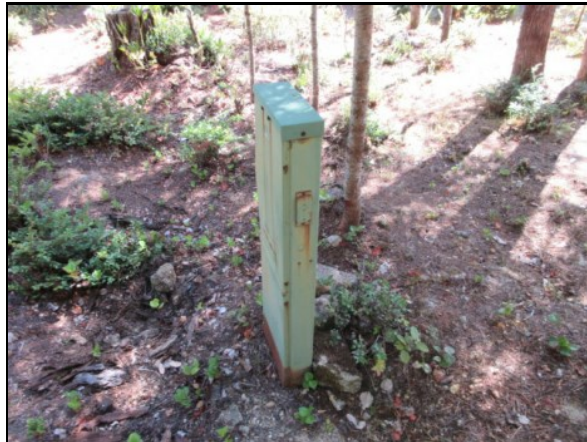
**Comp #: 2641 Electrical Pedestals (2025) - Replace**

Comments: This component funds the replacement of the remaining electrical pedestals that haven't been upgraded. The plan is to replace approximately 10 panels per year until they have all been replaced.

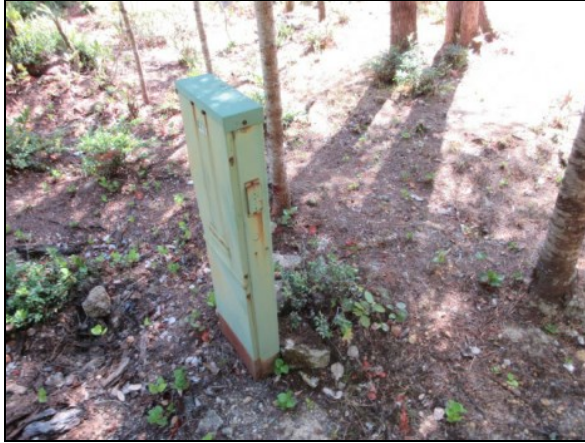
**Comp #: 2641 Electrical Pedestals (2026) - Replace**

Comments: This component funds the replacement of the remaining electrical pedestals that haven't been upgraded. The plan is to replace approximately 10 panels per year until they have all been replaced.

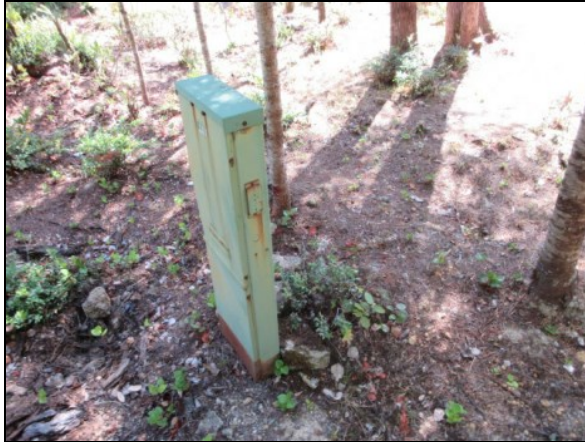
**Comp #: 2641 Electrical Pedestals (2027) - Replace**

Comments: This component funds the replacement of the remaining electrical pedestals that haven't been upgraded. The plan is to replace approximately 10 panels per year until they have all been replaced.

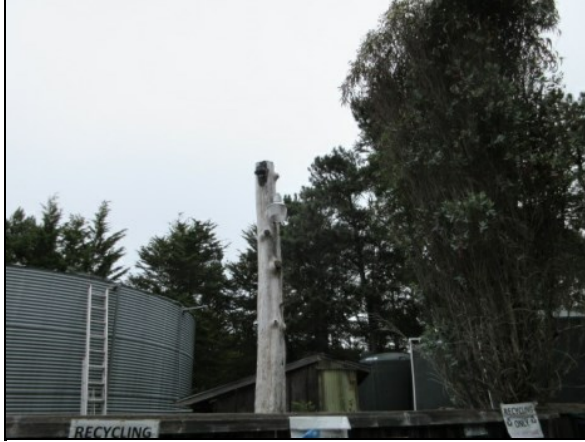
Comments: The pole light is upright and intact. We assume the fixture is fully functional at this time.

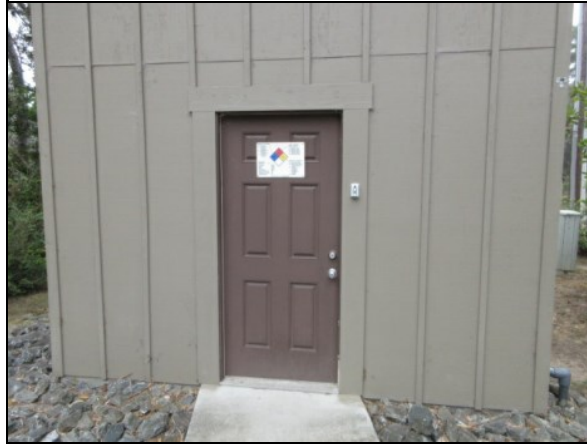
**Comp #: 703 Exterior Door - Replace**

Comments: The door is fully functional and has a satisfactory seal. We recommend setting aside funding for replacement in the interval outlined below.

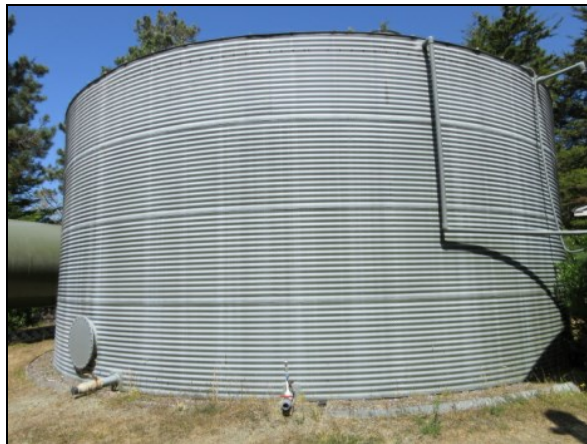
Comments: This component provides funding to reline the main water tank. We recommend periodic inspections to ensure the liner is aging correctly.

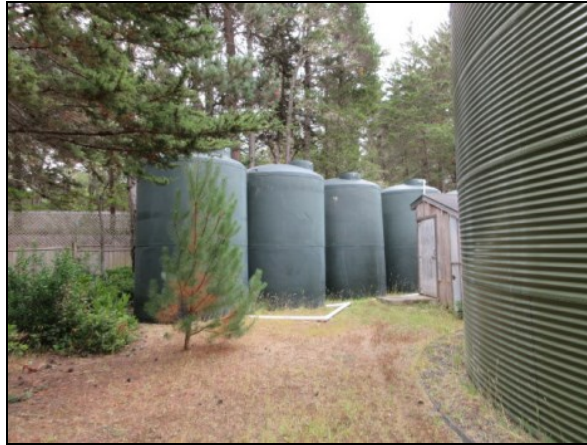
**Comp #: 806 Water Tanks - Replace**

Comments: Servicing vendors or maintenance staff should routinely inspect water storage tanks for leaks and other problems. Small repairs and cleaning should be considered Operating expenses and conducted as needed. We recommend setting aside funding for eventual replacement in the interval outlined below.

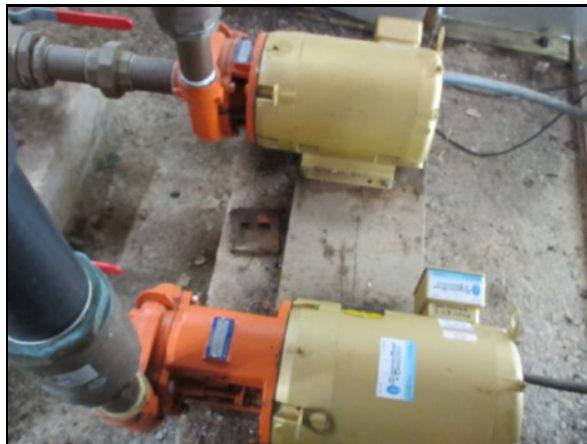
**Comp #: 807 Water Pumps & VFDs - Replace**

Comments: We recommend regular inspections to ensure the pumps are fully functional and aging correctly. Adjust the timing of replacement as future conditions dictate.

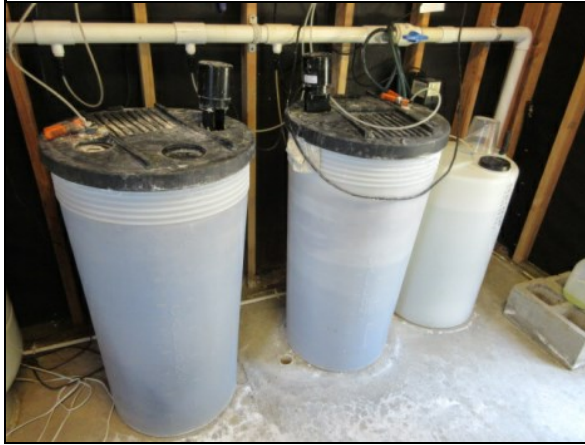
**Comp #: 811 Treatment Tanks - Replace**

Comments: No reported problems at this time. We recommend regular inspections by a licensed professional to ensure the water treatment system is fully functional and aging correctly.

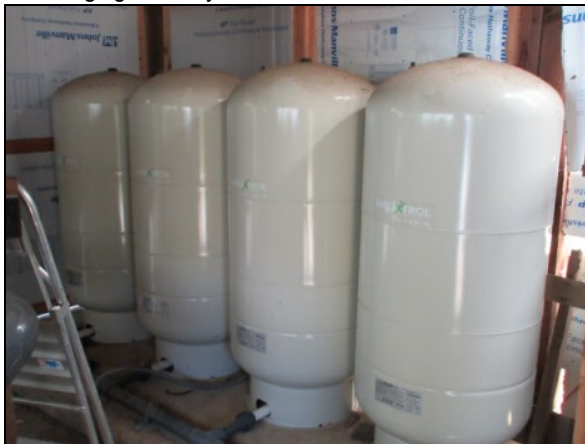
**Comp #: 830 Pressure Tanks - Replace**

Comments: No reported problems at this time. We recommend regular inspections by a licensed professional to ensure the water treatment system is fully functional and aging correctly.

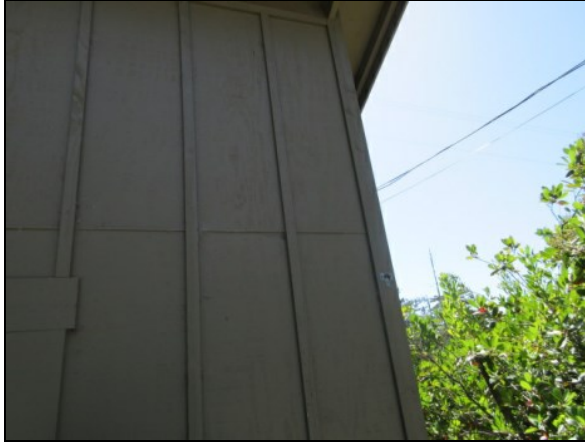
Comments: The paint is new and in fair condition. No peeling or other indications of premature deterioration noted. Painting is recommended every 10 years to preserve the exterior building surfaces and maintain appearance.

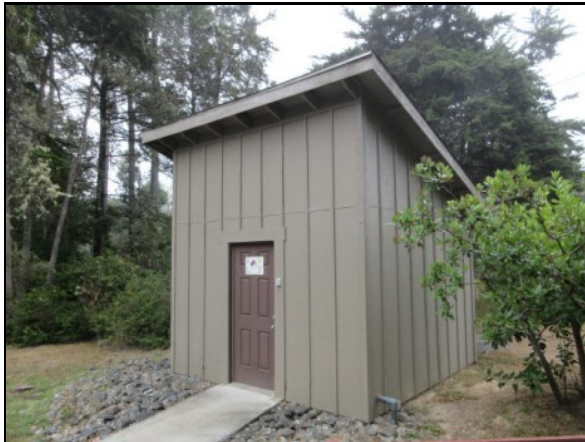
**Comp #: 1117 Building Exterior - Repair (Well)**

Comments: Funding is recommended for partial wood replacement due to the potential for termite damage, wood rot, and natural deterioration. Coordinate with painting for cost-efficiency purposes. We recommend an inspection by a licensed professional before painting to determine the scope of needed repairs. Adjust funding as future conditions dictate.

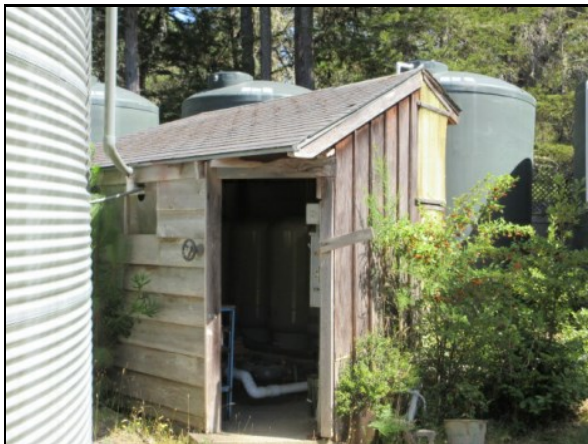
Comments: The pump house is nearing the end of its estimated useful life. We recommend setting aside funding to rebuild the structure in the near future.

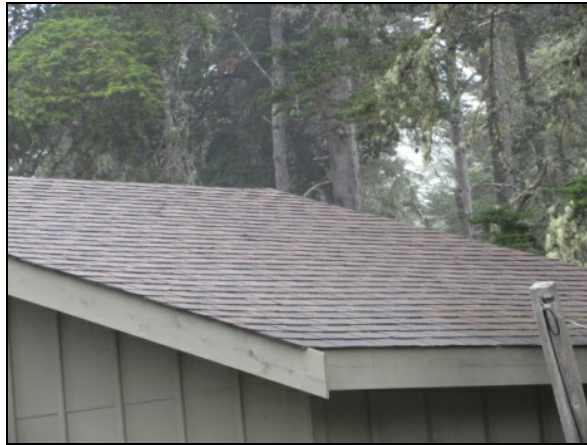
**Comp #: 1303 Comp Shingle Roof - Replace (Well)**

Comments: No significant warping, curling, or shingle detachment noted. We recommend periodic inspection by a licensed professional to ensure the roof is fully functional and aging correctly.

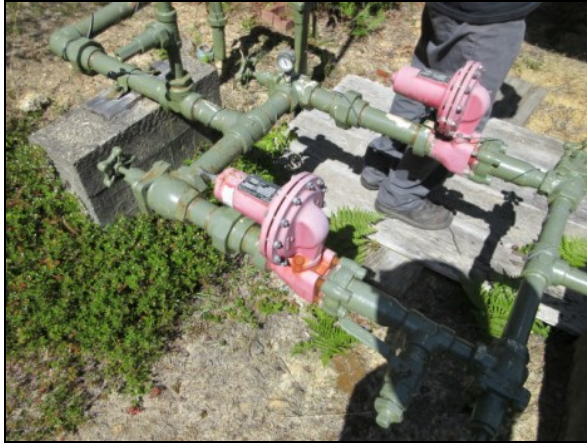
### Comp #: 1839 Regulators - Replace

Comments: This component provides funding for periodic replacement of the regulators. No problems have been reported at this time. We recommend regular inspections by a licensed professional to ensure the propane system is fully functional and aging correctly.
