**The Woods at Little River**  
*Little River, CA*

Report #: 51033-0

**RESERVE STUDY**  
"Full"

November 8, 2024

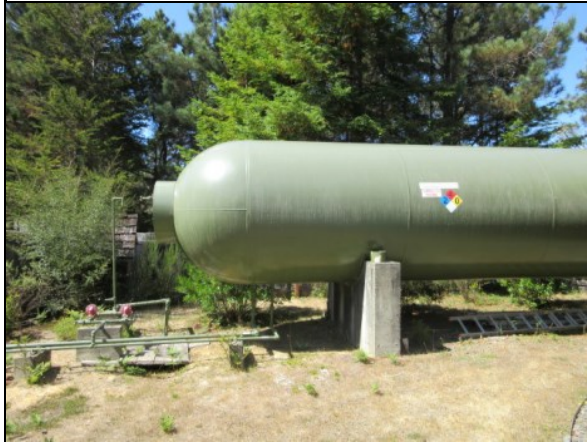
### Comp #: 1840 Propane Tank - Replace

Comments: We recommend periodic painting to protect against corrosion. Funding will need to be adjusted once a pattern of deterioration is observed.

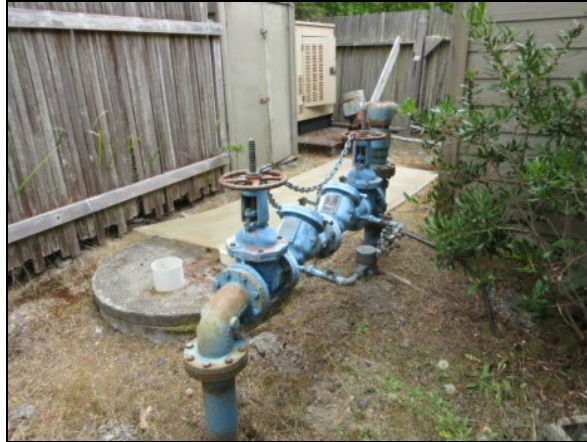
**Comp #: 312 Fire Backflow - Replace****Quantity: (1) Backflow**

Comments: The future of the Lodge is unknown at this time. We have excluded funding for replacement until the building's future use is determined.
